Examining Water Quality and Vegetation Along Cozine Creek Senior Capstone ENVS 460: Fall 2018

Sarah Schmidt, Chris Stinchcomb, Taylor Souza

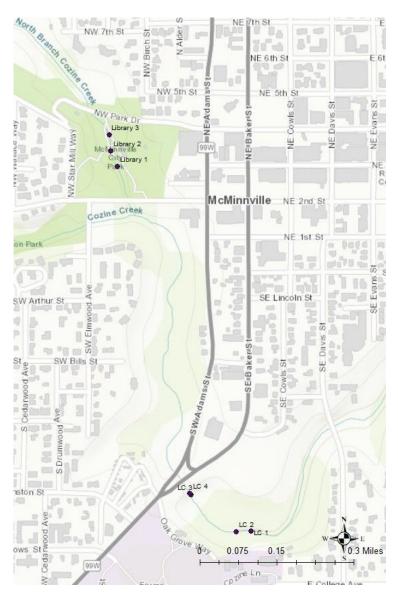
Figure 1. Locations of testing sites on Cozine Creek at Linfield College and at the Library Site. Map created based off GPS readings during sampling using Arcmap 10.6 (Created by Sarah Schmidt).

We measured water quality in Cozine Creek at two sites, Linfield College and City Park near the Library (Figure 1). At each site, we had three or four locations where we measured water quality. There were three sites along the main creek and one site at a side stream that flowed into Cozine Creek at Linfield College. We had three sites at a location further upstream, near the McMinnville Library in City Park. We recorded the GPS locations at each of these sites (Table 1).

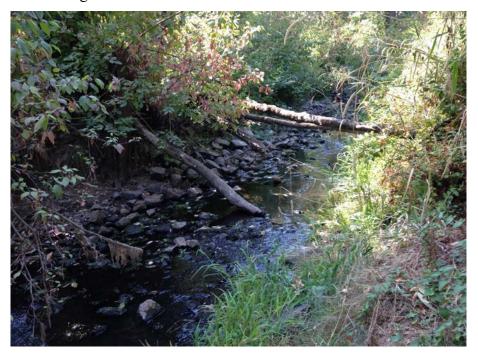
Figure 2. Cozine Creek as it flows through the Linfield Campus at subsite 2 (photo take September 5, 2018).

The second site, upstream from the first, had shaded, slow flowing, clear water. Bittersweet nightshade (*Solanum dulcamara*), Oregon ash, creek dogwood, and both species of blackberry were at this site was well. Fallen logs lay across the creek (Figure 2). The surrounding area to this site had been moved and treated with herbicides.

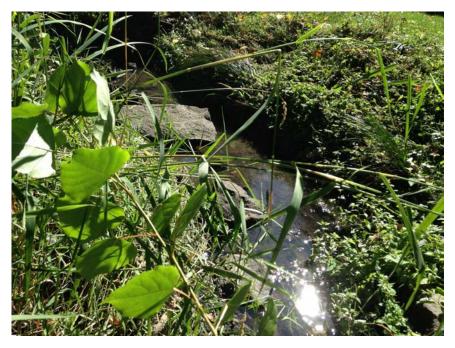
Figure 3. Cozine Creek as it flows through the Library site at subsite 3 (photo taken on September 19, 2018).

At the third site, large rocks covered the creek bottom and the water was clear and slow moving. A crawfish was seen under a rock in the middle of the creek. English ivy, field mint, trailing blackberry, and bittersweet nightshade plants were along the creek (Figure 3).

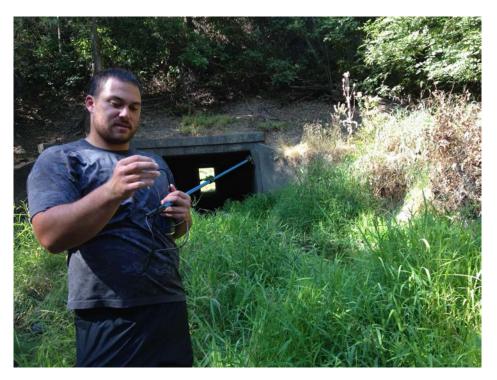
Figure 5: Chris Stinchcomb preparing the flow meter at subsite 3 on the LC site (photo taken September 5, 2018).

We measured the flow at each site location using a SwissFlow flowmeter (Model SF800) (Figure 5). The instrument was placed in the stream with the propeller facing upstream; the propeller could not be touching anything to get an accurate reading. Once the rate stabilized, the measurement was recorded. Flow was recorded five times with the propeller removed from the water between each reading.

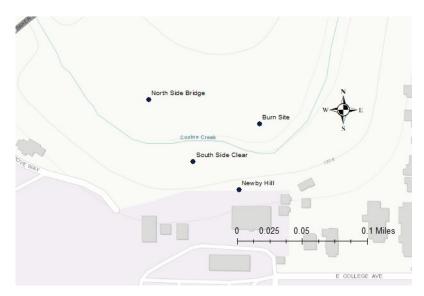
Figure 6. Location of the vegetation sites on the Linfield College campus. Map created based off GPS readings taken at each location and using Arcmap 10.6 (created by Sarah Schmidt).

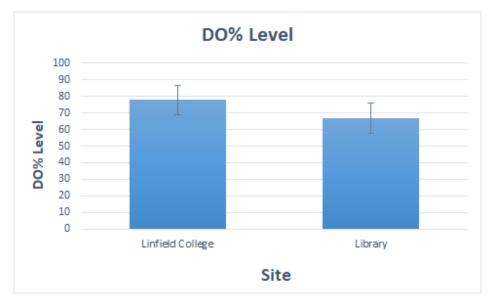
Figure 7: Mean (error bars are standard deviation) percent DO at each site. 90% DO represents the optimal level for salmon (Wasowski et al. 2013). p<0.0001.

Our results showed that water in Cozine Creek at Linfield College had significantly higher DO and temperature than the water in the creek at the Library site (Figures 7 and 8). These results could be related to low flow, but are most likely due to higher water temperatures in the Linfield College section of the creek due to less vegetation shading the creek at Linfield College. Regardless DO and water temperature at both sites were outside of those acceptable for salmon.

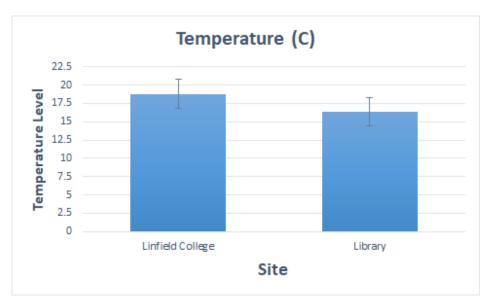
Figure 8: Mean (error bars are standard deviation) for temperature at each site. 12 degrees C is the upper temperature for salmon (USGS 2014; EPA 2003). p<0.0001.

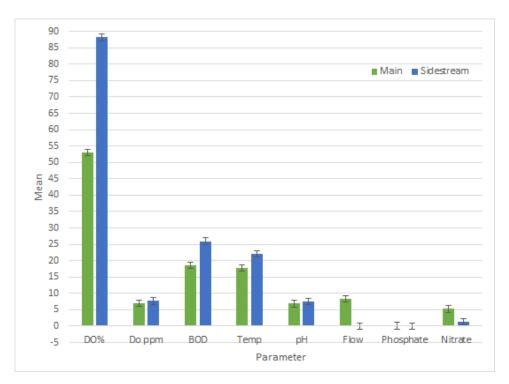
Figure 9: A comparison of water quality variables in Cozine Creek as it flows through the Linfield College site compared to the side stream that enters just above site 3. See Table 6 for statistical results.

For the first time, our class examined the water quality in a side stream that enters the main channel of Cozine Creek at Linfield College. The side stream flows from SE Baker Street to the creek by the third sampling site (the most upstream site). We originally believed the water came from storm runoff and excess rainwater, but the presence of the flow without recent rainfall indicated another source of water. Percent DO, BOD, temperature, flow, and nitrates were all significantly greater in the side stream (Figure 9 and Table 6) than in the main channel. It is possible that Cozine Creek at Linfield College had better water quality than the library site on the north fork as a result of the water entering from the side stream above our sample sites. The source of the side stream is unknown; it may be coming from groundwater, run off of irrigation water from the college, or a water leak McMinnville public water pipes. The source of the side stream should be further investigated.

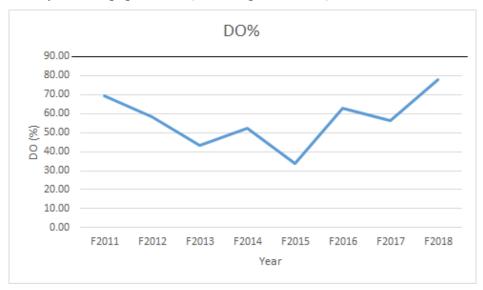
Figure 10: Mean DO (%) at the Linfield College site from fall 2011 through 2018. The black line represents the ideal dissolved oxygen level (90%) for a salmon-bearing stream (Wasowski et. al 2013).

Although DO varied over the years, dissolved oxygen levels were significantly higher in 2018 compared to previous years. Even so, it remains below the optimal level for a salmon-bearing stream (Figure 10). Low DO is dangerous to aquatic life, especially salmon, posing problems with reproduction and survival. Well oxygenated water allows fish to thrive and their

smolts to develop fully (Wasowski et. al 2013). Low levels of DO may be attributed to the low flow and high temperature every summer. Low flow reduces oxygen diffusion into the water, and along with high temperatures, leave the water less oxygenated and unable to support healthy salmon populations (Breitburg et al. 1997).

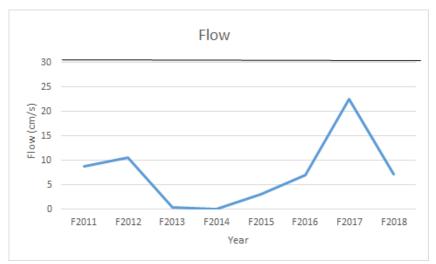
Figure 11: Mean flow at the Linfield College site from fall 2011 through 2018. The black line represents the optimal minimum flow value for salmon (30.48 cm/s) (EPA 2012).

Although flow has fluctuated widely, we found it was significantly lower in 2018 compared than 2017 (Figure 11). Even during higher recorded flows, it has remained under the optimal minimum rate set by the EPA for salmon, 30.48 cm/s (EPA 2012). A low flow correlates with higher water temperatures because stagnant water can absorb more sun. Because water movement disperses oxygen a lack of flow also relates to a lower DO. The low flow in Cozine Creek, along with high water temperature, are likely contributing factors to the low DO that has been a continuous trend. Flow also relates to the amount of precipitation that occurred prior to testing, so the observed fluctuations in flow could have been caused by different levels of rain prior to testing (USGS 2016c).

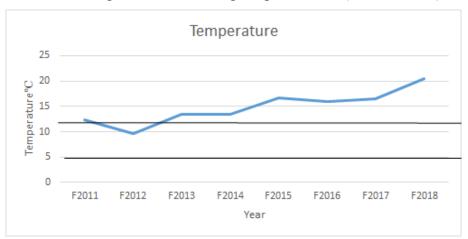
Figure 12: Comparison of mean temperature at the Linfield College site from fall 2011 to 2018. The black line represents the maximum temperature for salmon (USGS 2014; EPA 2003).

Temperature was higher in 2018 than in previous years of study and showed a tendency to increase over time (Figure 12). Temperature is a key factor in overall water quality. The maximum optimal temperature for salmon is 12°C (USGS 2014), which has been exceeded every year except 2012. Warmer water holds less dissolved oxygen and will affect the distribution, health, and survival of salmonids. High temperatures increase stress and disease in fish (EPA 2003). The increasing trend in temperature may be the result of warmer temperatures recorded in Oregon summers during the past decade (KOIN 6 2018).

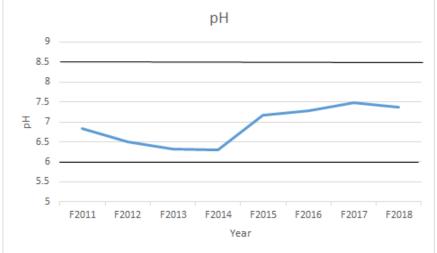
Figure 13: Comparison of pH at the Linfield College site from fall 2011 to 2018. The black line represents the ideal range for salmon habitat (6.0-8.5) based on DFO 1983.

pH has fluctuated over the years, but has remained in the acceptable salmon bearing range of 6.0 to 8.5 (Figure 13). pH levels outside of this range increase the likelihood of blood related issues such as reduced blood oxygen carrying capacity that can lead to issues related to reproduction and survival (DFO 1983). Cozine water had a pH 7.37. In the earlier years of study the pH was slightly more acidic; this difference could be a result of fertilizers used in nearby agricultural and urban areas (Fondriest Environmental 2013b).

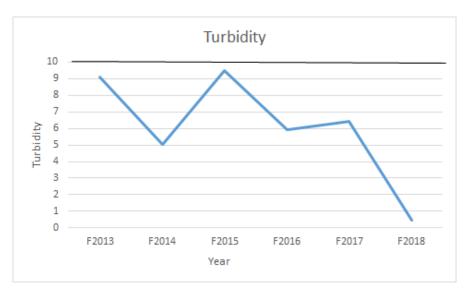
Figure 14: Comparison of mean turbidity at the Linfield College site in fall 2011 through fall 2018. Levels greater than 10 FTU prevent light from passing through the water (Minnesota Pollution Control Agency 2008).

Turbidity has been variable, although the trend is downward (Figure 14). Turbidity levels have been below 10 FTU every year. Turbidity did decrease significantly in 2018 relative to previous years. This does not necessarily mean we have better water quality (since it only decreased in the most recent year), but it is an indicator that water quality might be improving.

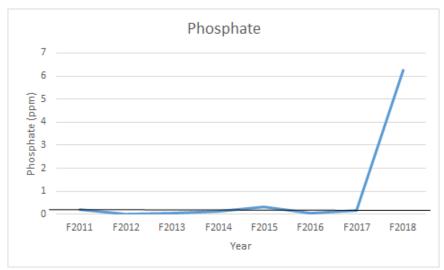
Figure 15: Mean phosphate at Linfield College from fall 2011 to fall 2018. The black line represents optimal level of phosphate for a salmon-bearing stream.

In 2018, phosphate levels were significantly higher than had been previously measured (Figure 15). This level was above that acceptable for salmon (Jensen 2010).

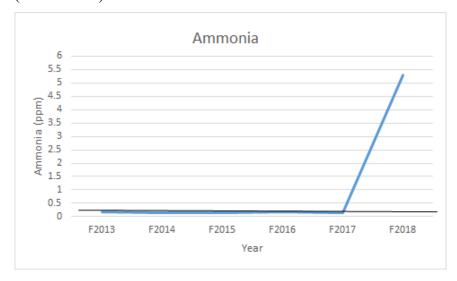
Figure 16: Mean ammonia at the Linfield College site from 2011 to 2018. The black line represents optimal level of phosphate for a salmon-bearing stream.

Similar to phosphate, ammonia increased significantly compared to previous years (Figure 16). This was much higher than the salmon tolerable level (approximately 0.25 ppm)

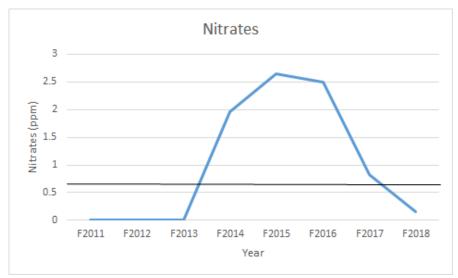
Figure 17: Mean nitrate at Linfield College from fall 2011 to 2018. The black line represents optimal level of phosphate for a salmon-bearing stream.

In comparison to the other two nutrients, nitrate concentration decreased in 2018 (Figure 17). It is now within the range tolerable for salmon (Jensen 2010).

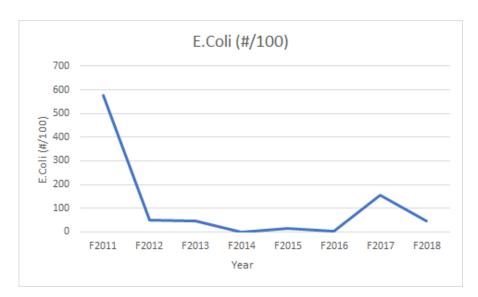
Figure 18: Mean *E. coli* counts at Linfield College from fall 2011 to fall 2018.

Levels of *E. coli* decreased in 2018 compared to fall 2017, and were much lower than the levels in 2011 (Figure 18). The decline over time suggests a major reduction in fecal contamination. The EPA has set safe *E.coli* levels in recreational waters to be less than 406 *E.coli* per 100mL . The *E. coli* levels found indicate Cozine Creek water would be safe for recreational use (EPA 2017b).

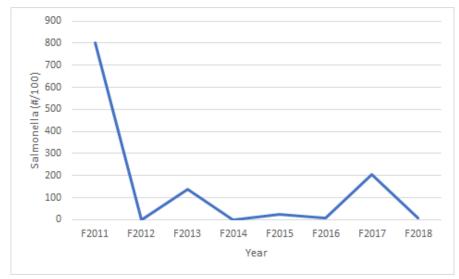
Figure 19: Mean Salmonella counts at Linfield College from fall 2011 to fall 2018.

As with *E. coli, Salmonella* was lower in 2018 compared to 2011 and 2017 (Figure 19). This decrease further supports a major reduction in fecal contamination of the water.

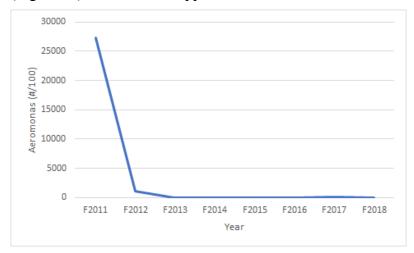
Figure 20: Mean *Aeromonas* counts at Linfield College from fall 2011 to fall 2018.

Aeromonas dropped dramatically in 2012 and 2013 and has remained near zero since (Figure 20). This further supports a decline in fecal contamination in the creek.
