# Linfield College

## Cozine Creek Inventory and Assessment

ENVS 485 Environmental Problem Solving  
Linfield College, Spring 2016

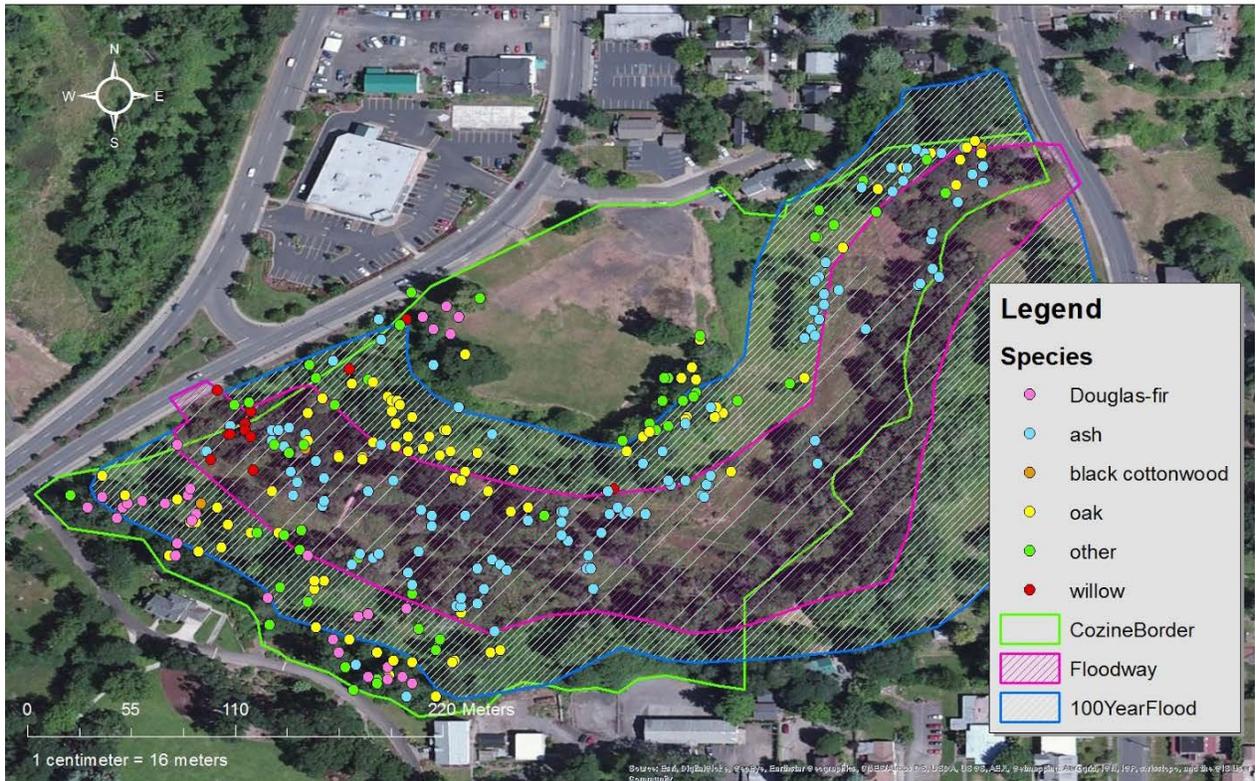
Figure 1.2: Map of location of trees >20cm dbh relative to floodplain (made by Reese Yonemura)

We analyzed the distribution of trees species on the property with respect to the floodplain status (Figure 1.2). A distinction, however, was found in examining tree distribution in the floodway, which is defined as a channel of a river or other watercourse and the adjacent land areas that must be reserved in order to discharge the base flood without cumulatively increasing the water surface elevation more than a designated height (FEMA 2016). This is the area that floods annually. The Oregon white oak trees were not in the floodway, whereas the majority of the ash were within it. This indicates a separation between the oak woodland habitat and riparian habitat found on the property.

We noticed some Douglas-fir and ash trees growing under some large oaks outside the floodway and this is concerning because the ash trees on this property are growing at three times the rate of the oaks. These young trees can quickly outgrow and shade out the large oaks eventually leading to the oaks' death.

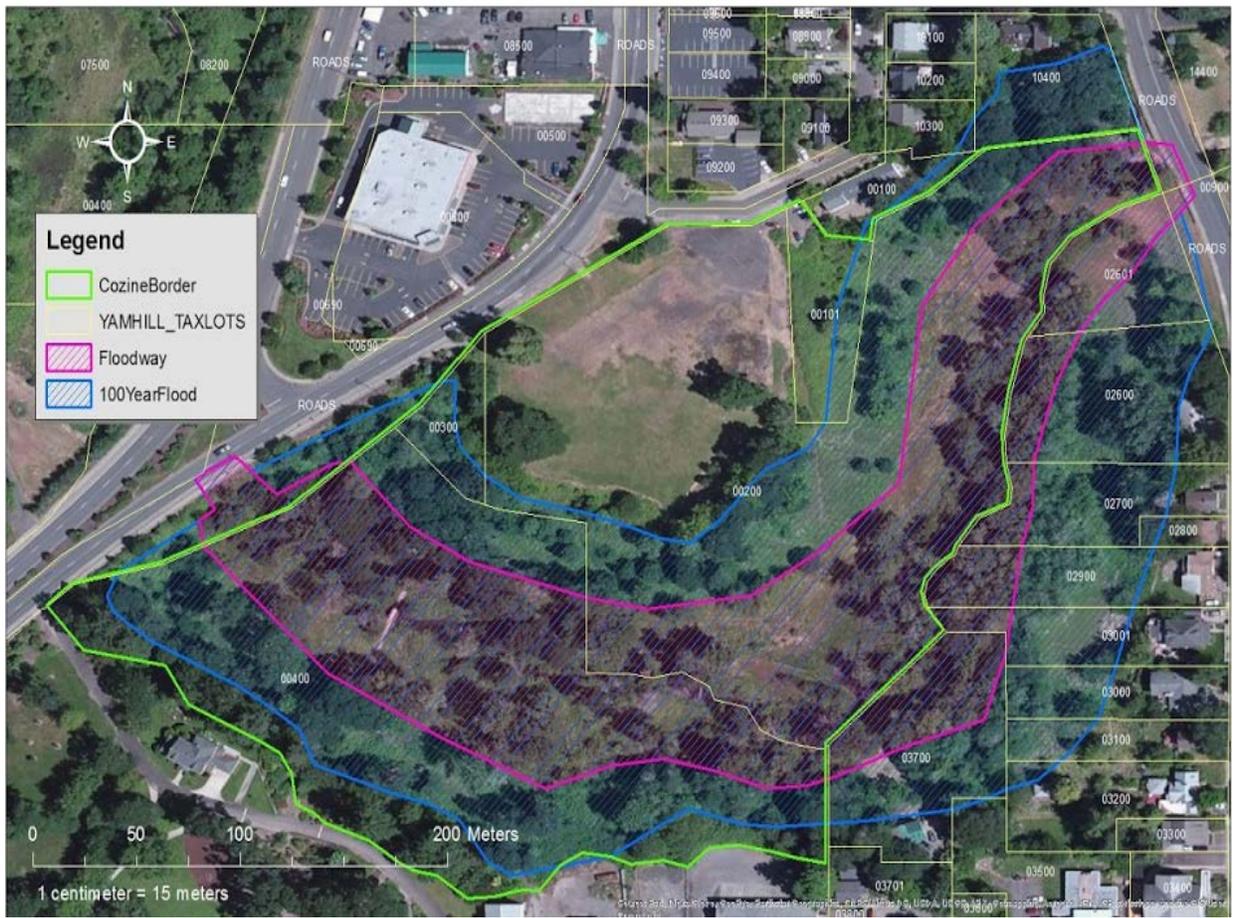
Figure 1.4: Map of 100 year flood zone and floodway in Cozine Creek (made by Reese Yonemura)

Yamhill County frequently deals with periodic flooding events caused by intense rainfall from large winter storms occurring between late October and the end of April (Figure 1.4). Cozine Creek often experiences major flooding in December, January, and February. The earliest floods in the region after Europeans arrived were recorded in 1843 and 1844. In 1861 a 100-year flood event occurred. This is considered by some to be the largest flood witnessed by residents, but no measurements of volume were taken at that time. The largest recorded flooding event occurred in 1996 and peaked at a discharge of 47,000 cubic feet per second (Lucker 2011). The average peak flow for Cozine Creek is 17.45 cubic feet per second above Davis Street and 9.8 cubic feet per second further upstream, west of Fellows Street. The flow can increase dramatically after heavy rainfall and the backup of the South Yamhill River (Johnson and Sullivan 1999).

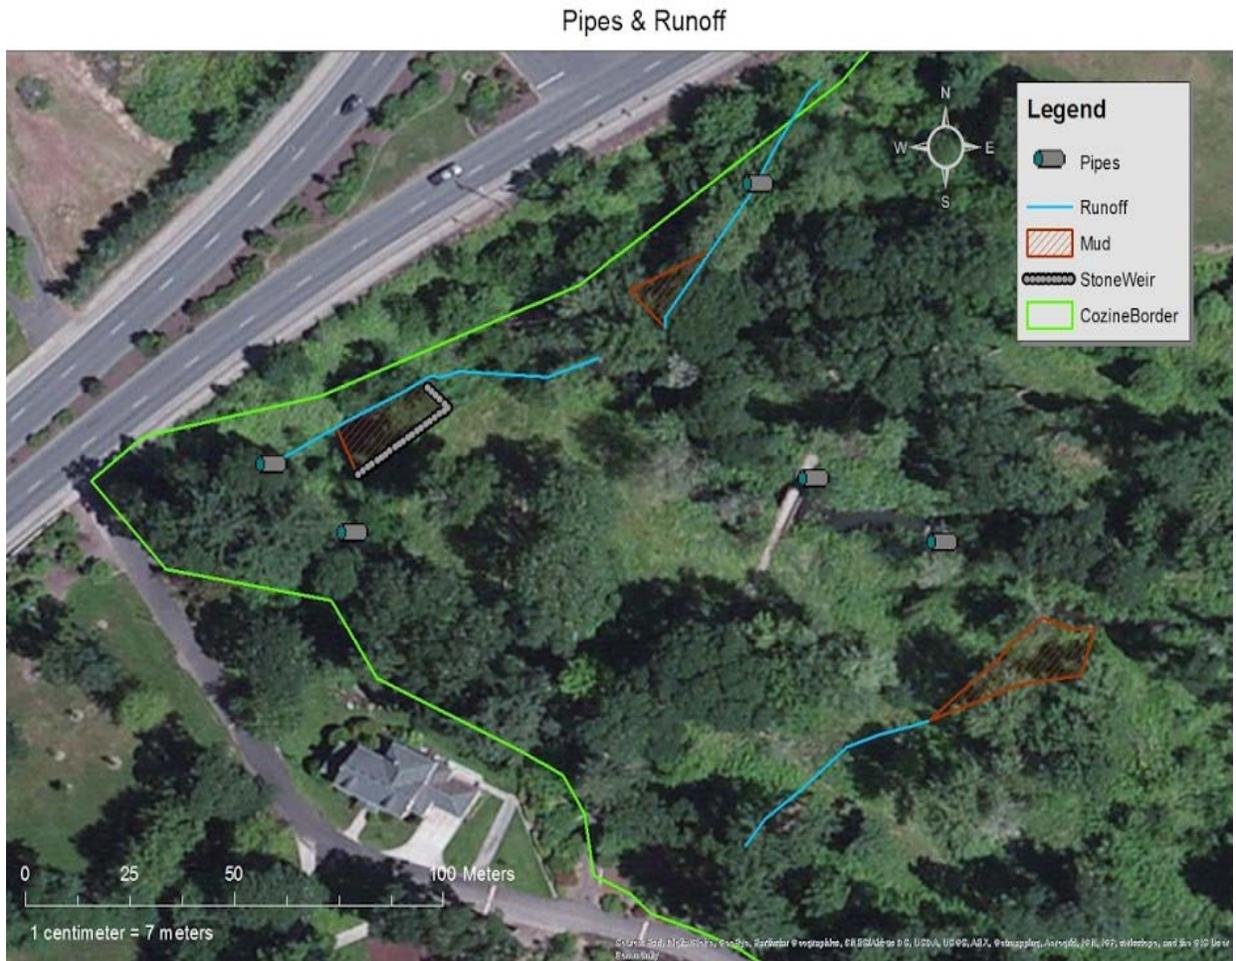
Figure 1.5: Map of stormwater pipe locations and sewer manhole covers in Cozine Creek (made by Reese Yonemura)

The City of McMinnville relies on Cozine Creek as one of its perimeter endpoints of stormwater drainage, especially during flood events. Stormwater runoff flows to Cozine Creek either by pipes or in natural open channels. There are also numerous manhole covers that lead to the McMinnville sewer system that runs under Cozine Creek (Figure 1.5). Approximately two-thirds of McMinnville’s storm drains eventually discharge into the creek, and much of McMinnville’s drainage system has storm drains that are undersized. These factors result in annual flooding. Currently, there are no requirements by the U.S. Environmental Protection Agency (EPA) on stormwater quality for the city of McMinnville. Recommendations by the EPA have been made to monitor the stream’s water quality, although little action has been done because Cozine Creek is considered a lower priority than other streams in the county.

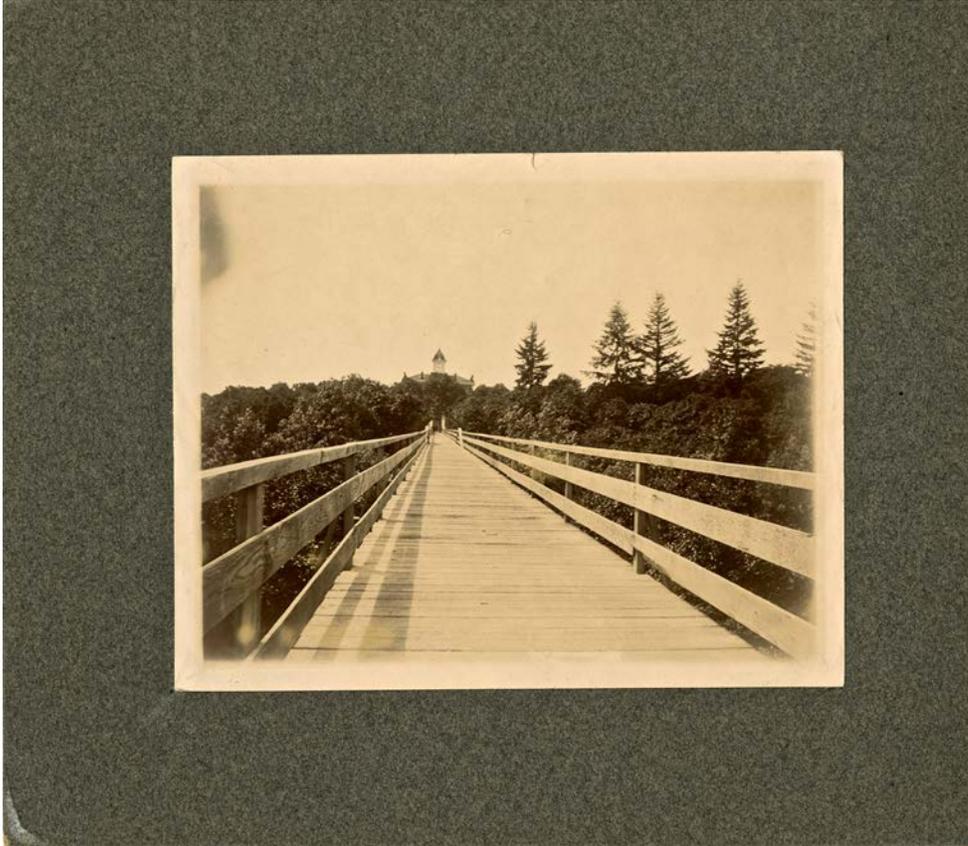
**Figure 2.2** Photograph of Cozine Bridge from town looking at Pioneer Hall (Linfield College Archives 2012).

In 1902 a footbridge was built across the Cozine Creek Ravine. The original bridge was located in front of Pioneer Hall connecting on the other side of the ravine where Columbus High School was located (Figure 2.2). The earliest photograph we found was taken in 1903 (Linfield College Archives 2012). A new deck and railings were added to the footbridge in 1917 at a cost of \$437.50 (McMinnville College Bulletin A 1917).

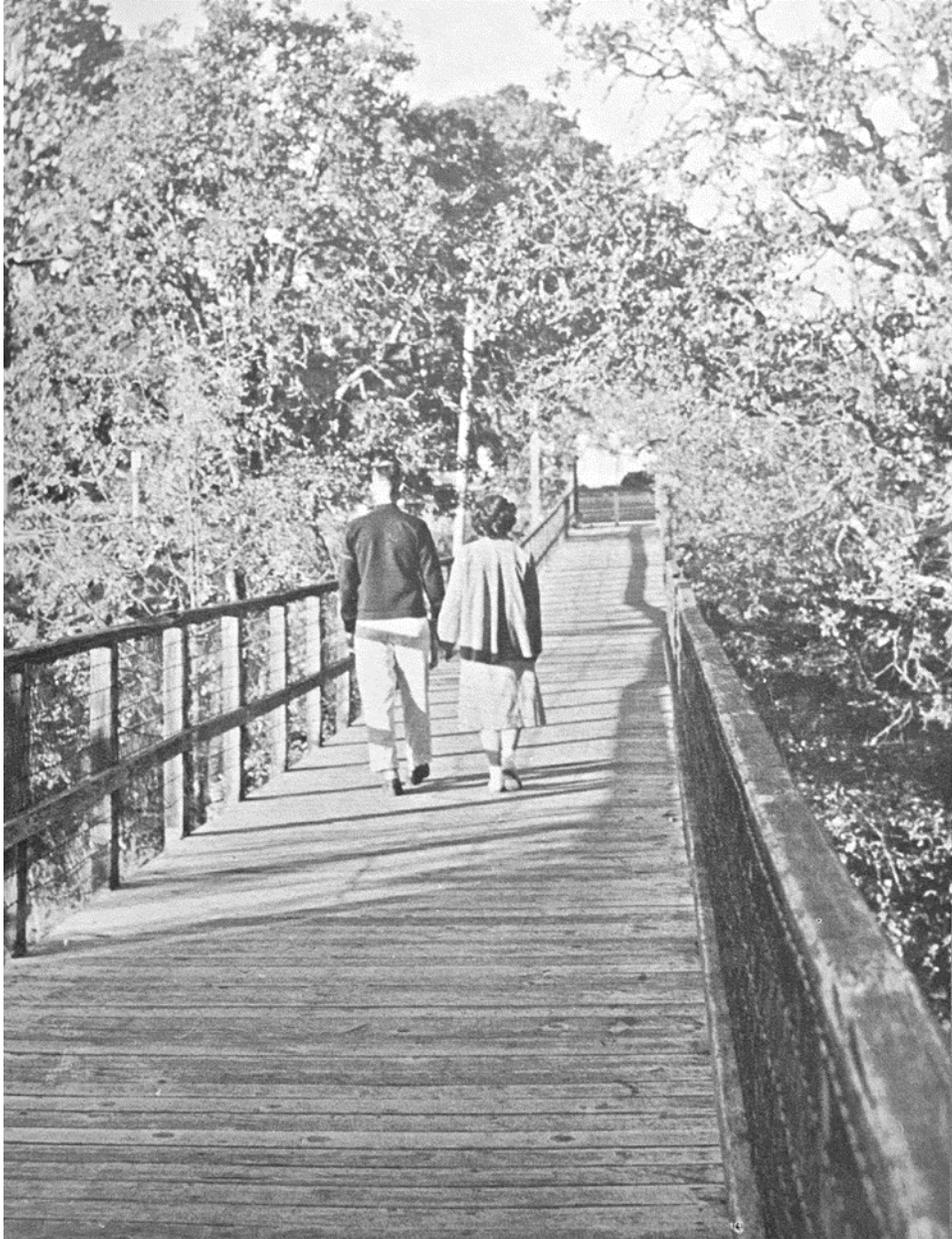
**Figure 2.3** Two people cross the Cozine Footbridge, also known as Linfield's Lovers' Lane (Holmes 1956).

In the 1930s, as part of landscape improvements, Dwight Miller tore down the bridge and rebuilt an entirely new one. Construction of the second bridge, which did not take place until 1938 when Dr. William G. Everson was elected president of the college, resulted in the bridge moving nearer to the President's house. The President's house and Pioneer Hall are helpful to use as landmarks to understand where the footbridge was located (Holmes 1956). Miller in 1947, replaced the sills and deck of the bridge (McMinnville College Bulletin B 1947). The Cozine Footbridge was considered the main entrance to campus and was also known as Lovers' Lane, as Linfield couples strolled the bridge that crossed the Cozine Ravine (Figure 2.3).

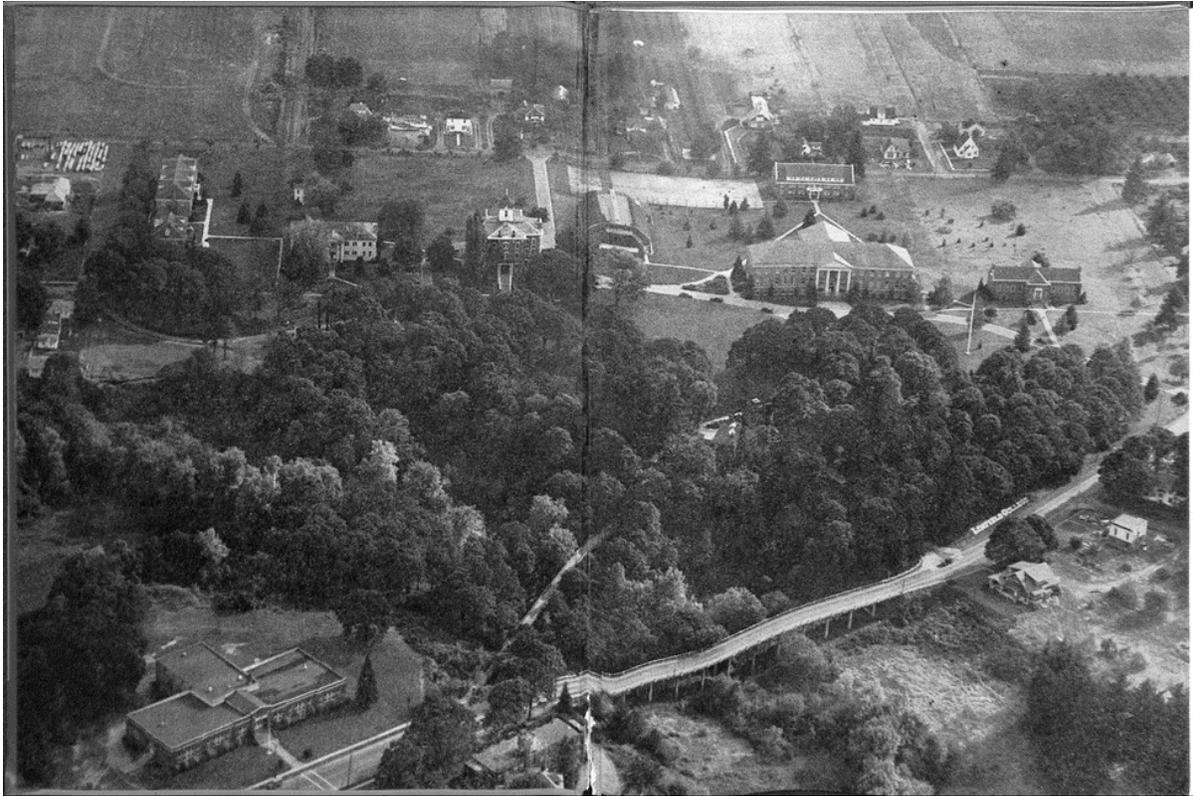
**Figure 2.5** An aerial photograph of Linfield College, Columbus School (lower left corner), and the Baker Street bridge over Cozine Creek. Also, slightly visible is the footbridge over the Ravine (Oak Leaves, 1946).

lars, and the street was one lane going in each direction (Figure 2.5). This structure allowed water and wildlife to pass through underneath. At some point in the 1950's the roadway was widened to two lanes in each direction and the bridge was replaced with a cement culvert that has limited the movement of water and wildlife along the creek.

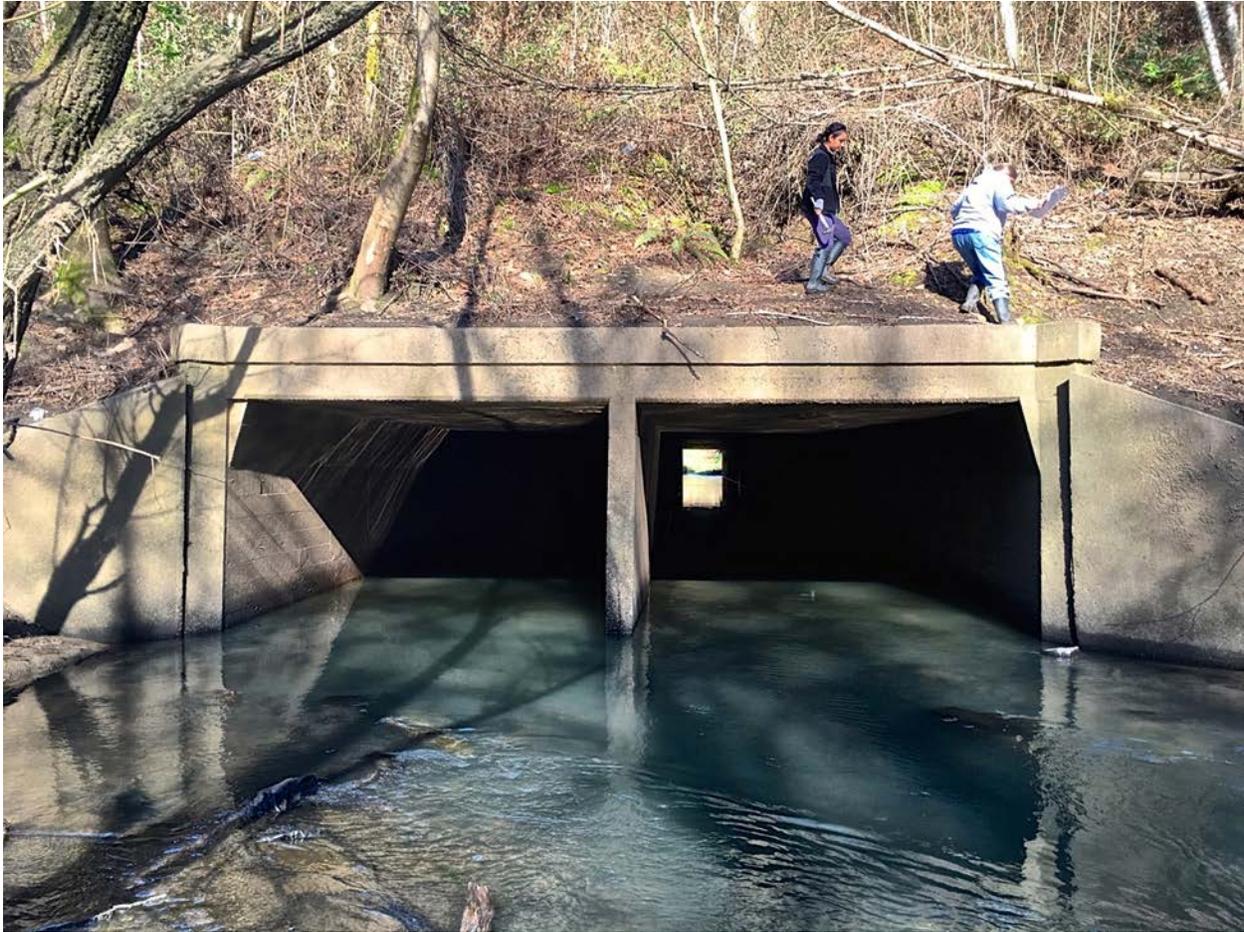
**Figure 2.8** Culvert at Western end of property. Photograph by Rachael Gernhart 2016.

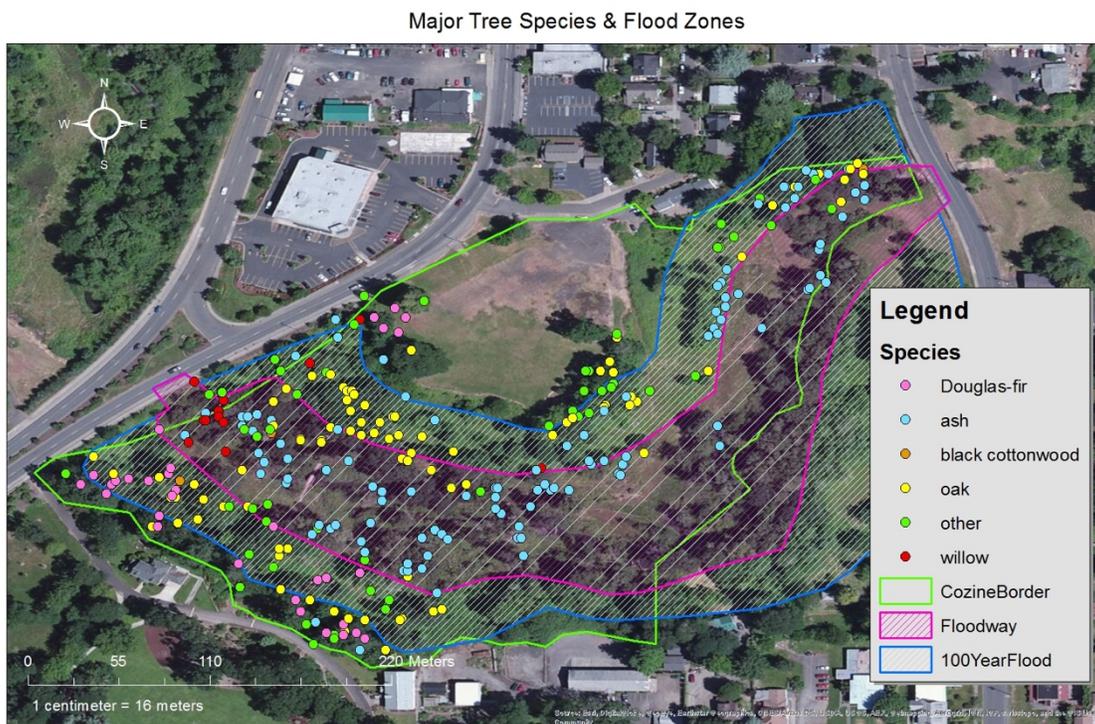
Figure 1.2: GIS map of location of trees >20cm dbh relative to floodplain (made by Reese Yonemura)

We analyzed the distribution of trees species on the property with respect to the floodplain status (Figure 1.2). A distinction, however, was found in examining tree distribution in the floodway, which is defined as “a channel of a river or other watercourse and the adjacent land areas that must be reserved in order to discharge the base flood without cumulatively increasing the water surface elevation more than a designated height” (FEMA 2016). The majority of Oregon white oak trees were not in the floodway, whereas the majority of the ash trees were within it. This indicates a separation between the oak woodland habitat and riparian habitat found on the property.

We noticed some Douglas-fir and ash trees growing under some of the large oaks outside of the floodway. This is concerning because the ash trees on this property are growing at three times the rate of the oaks and Douglas-fir is also a rapid growth tree species. Such young trees

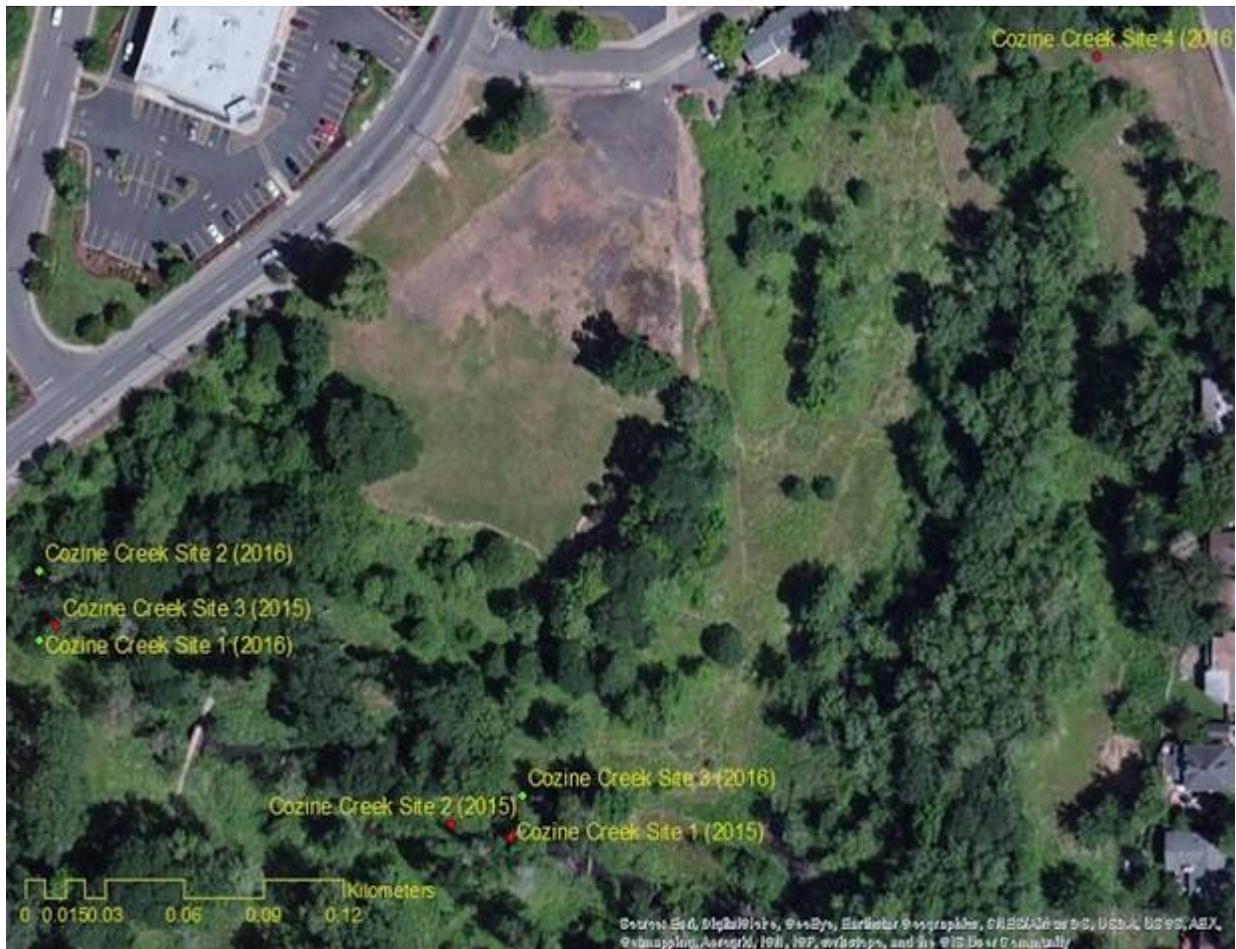
Samples were collected from four sites on Cozine Creek on March 10<sup>th</sup> and March 31<sup>st</sup>, 2016 (Figure 3.1). The temperature on March 10<sup>th</sup> was 46°F, and the weather was rainy. Cozine Creek was swollen due to heavy rainfall in the week before sampling. The week of March 10<sup>th</sup> had approximately 2.61 inches of rain. The temperature on March 31<sup>st</sup> was 58°F and the weather was clear and sunny. The week before March 31<sup>st</sup> had an average total rainfall of 0.03 inches (Weather Underground 2016). Four sites were chosen along Cozine Creek, spanning from U.S. 99 to Davis Street. Site 1 was located on a shallow, storm water, side stream running into Cozine Creek approximately 10 meters from the bridge over U.S. 99. The stream was approximately one meter wide and the stream's bottom was covered with large sharp rocks. Site 2 in this study was at site 3 in the 2015 ENVS 385 sampling sites on Cozine Creek. For a site description refer to the ENVS 385's site description for site 3 (Blanco et al. 2015). Site 3 in this study was located at site 2 in the 2015 ENVS 385 sampling sites on Cozine Creek. For a site description refer to the ENVS 385's site description for site 2 (Blanco et al. 2015). Site 4 was located on Cozine Creek just before it flowed into a concrete culvert that travels under Davis Street. Site 4 was approximately four meters wide, flooding into a nearby grass field to the east. The creek banks were eroded and muddy with some woody debris.

Figure 3.1: GIS map of ENVS 385 fall 2015 (red dots) and ENVS 485 spring 2016 (green dots) water sample sites for Cozine Creek (made by Reese Yonemura)

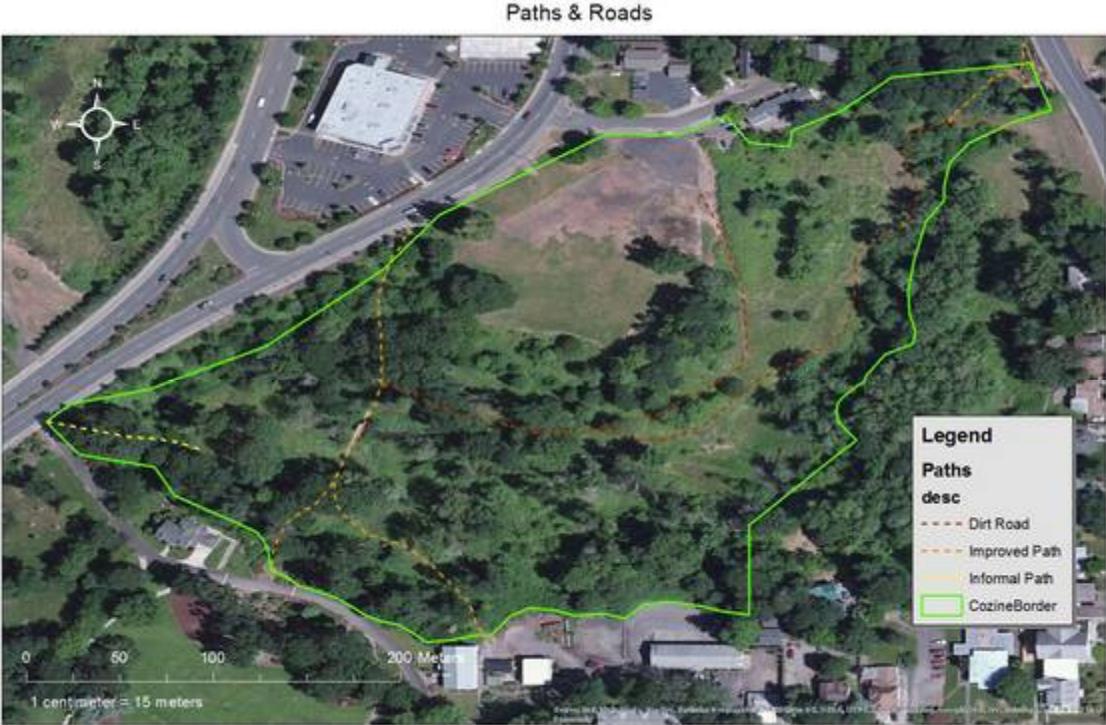
Figure 1: The different routes through the Cozine site and their classifications.

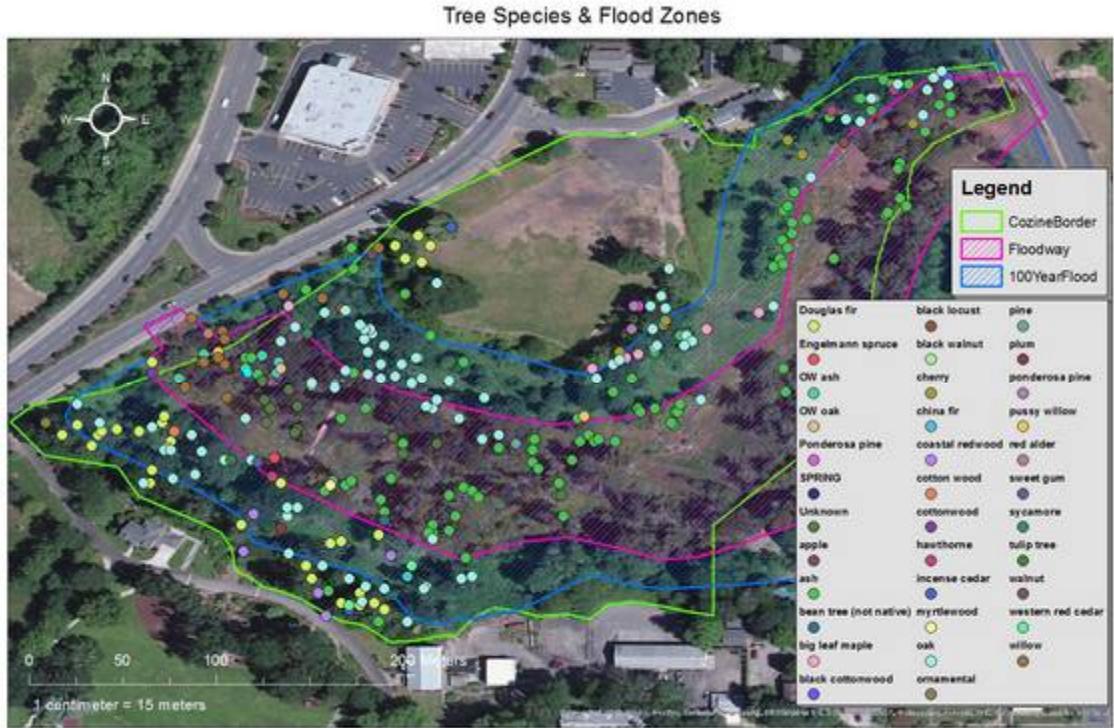
Figure 2: All of the trees measured with a DBH greater than 20cm and their species, in relation to the different flood zones.

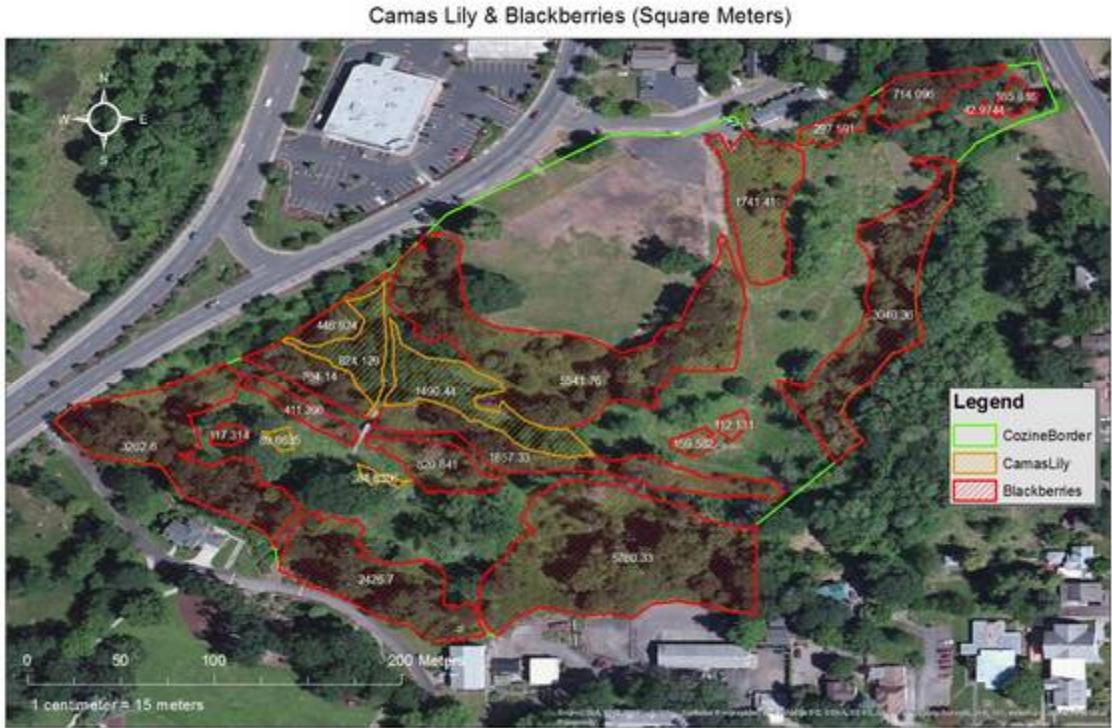
Figure 3: The expanse of Camas lily and Himalayan blackberries. Area represented in square meters.

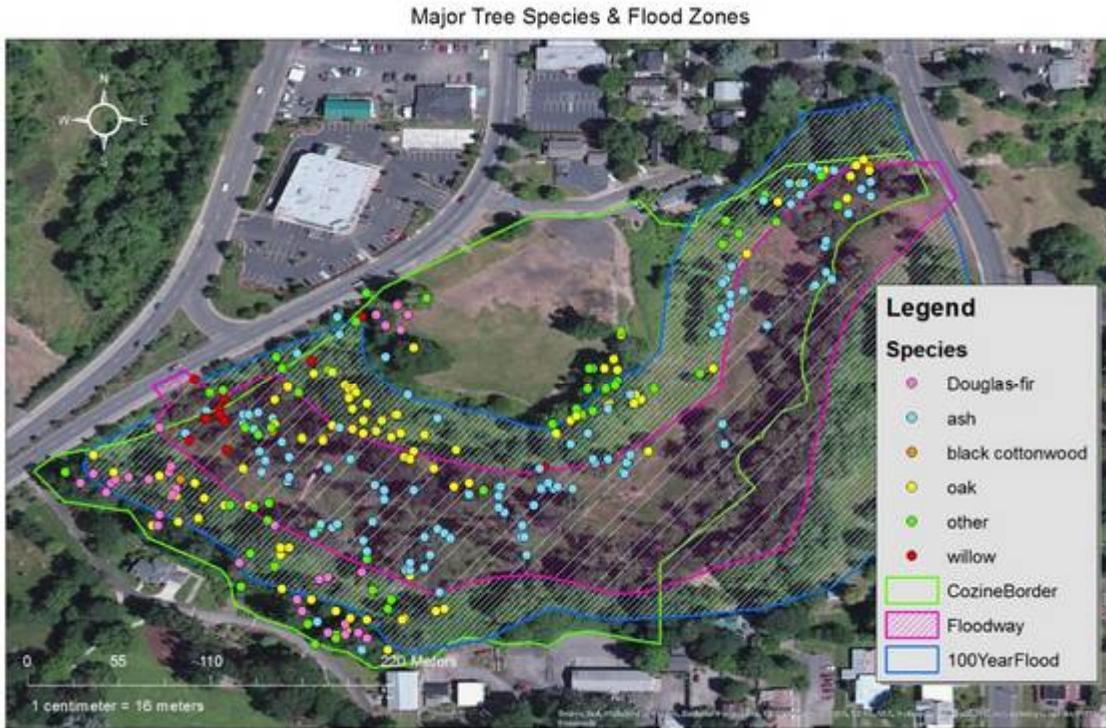
Figure 5: This is the tree data filtered down to only represent the major tree species within the site in relation to the flood zones.

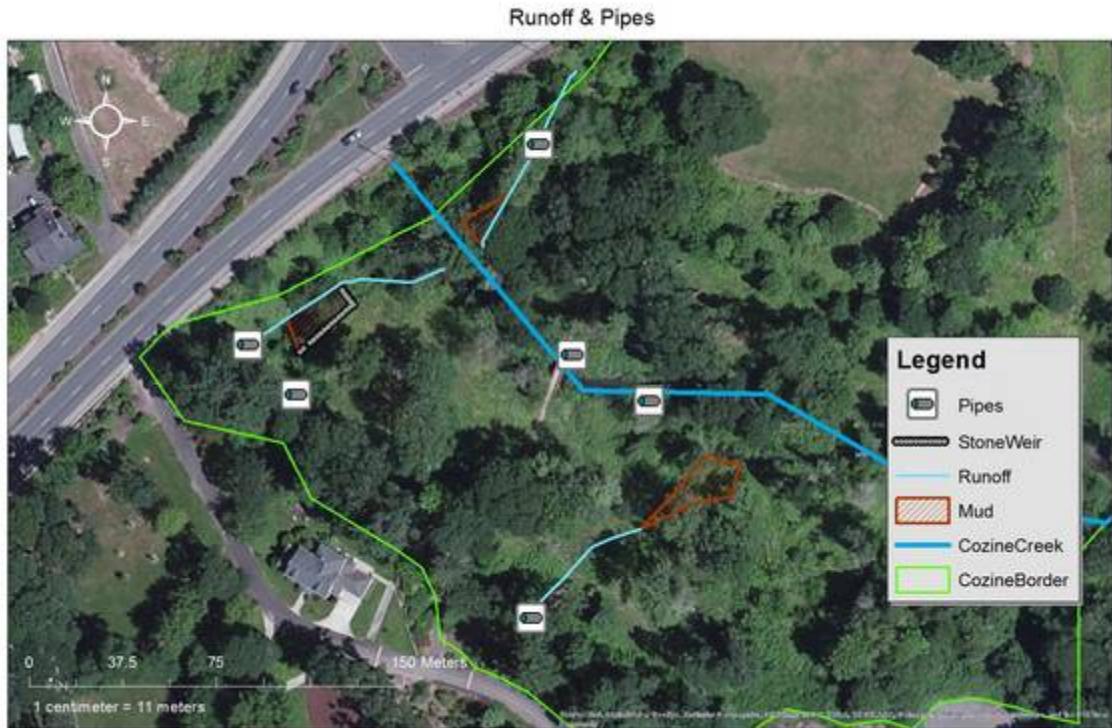
Figure 6: The location of pipes and the paths runoff follows. Other factors that affect runoff, including weirs and mud fields are also shown.

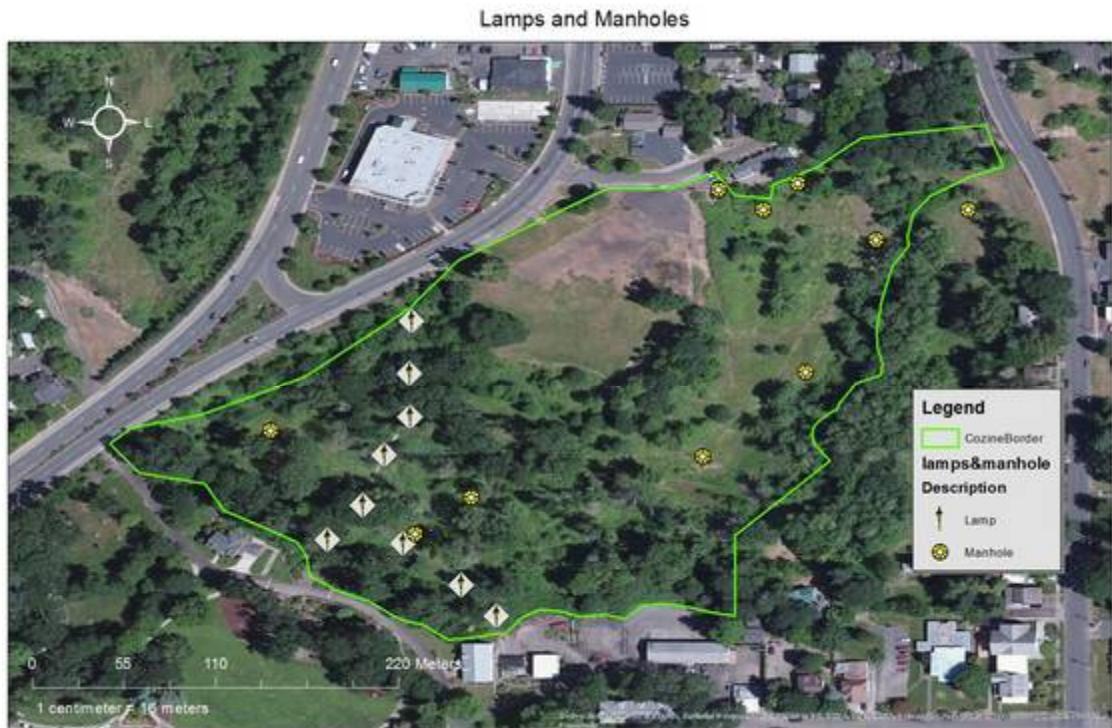
Figure 7: The locations of manholes and lamps throughout the site.
